Manhole Inspection Summary

Manhole # S19E__011MH

Insp Date: **10/10/07 12:24 PM**

Location Address: **2200 SMALLWOOD ST**

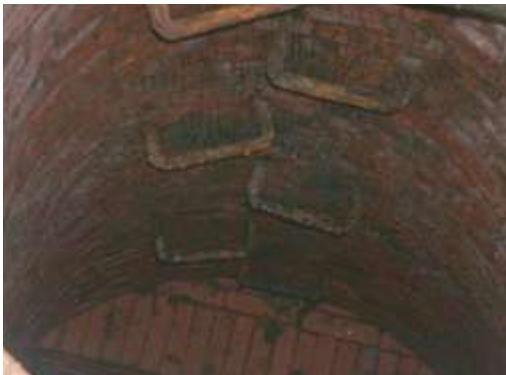
Defect 2

Count: **6** Missing: **0** ☒ **Corroded**

CORRODED STEPS

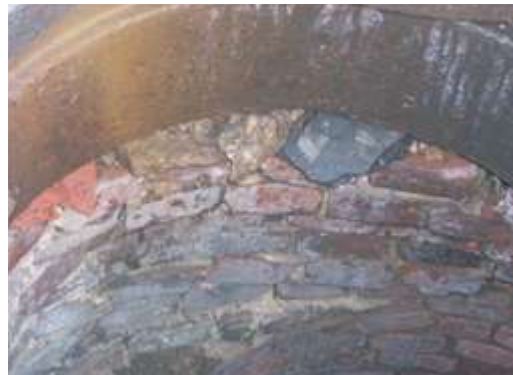
Defect 1

Condition: ☐ Sound ☐ Cracked ☐ Root Intrusion ☐ Loose Brick ☒ **Deteriorated**

CHIMNEY DETERIORATION

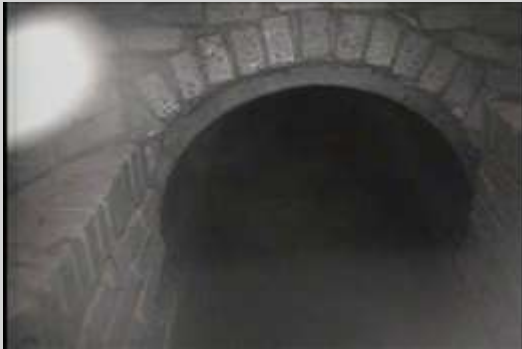
12 O'Clock Outflow

Pipe Height: **27.6** (in.) Rod and Bar (Angled)
Pipe Material: **Clay** ☐ Pipe Lined
Invert Depth: **13.52** (ft.) Flow Characteristics: **Slow**
Deposits: ☒ None ☐ Mud ☐ Sludge ☐ Debris ☐ Grease
Silt Depth: (in.) Deposits Extent:
Infiltration: **None** Pipe Seal Cond: **Sound**

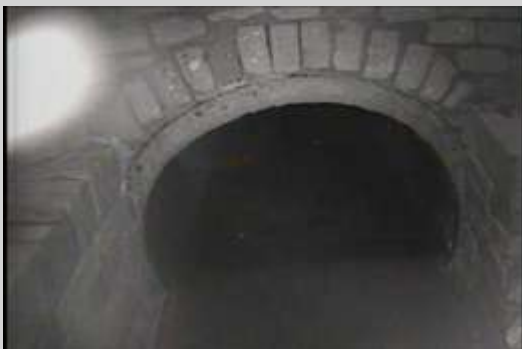
6 O'Clock Inflow

Pipe Height: **27.6** (in.) Rod and Bar (Angled)
Pipe Material: **Clay** ☐ Pipe Lined
Invert Depth: **13.41** (ft.) Flow Characteristics: **Slow**
Deposits: ☒ None ☐ Mud ☐ Sludge ☐ Debris ☐ Grease
Silt Depth: (in.) Deposits Extent:
Infiltration: **None** Pipe Seal Cond: **Sound**
